“Motor Testing” Which Road Will You Take?

Dave Humphrey
Allison Transmission
Indianapolis, IN

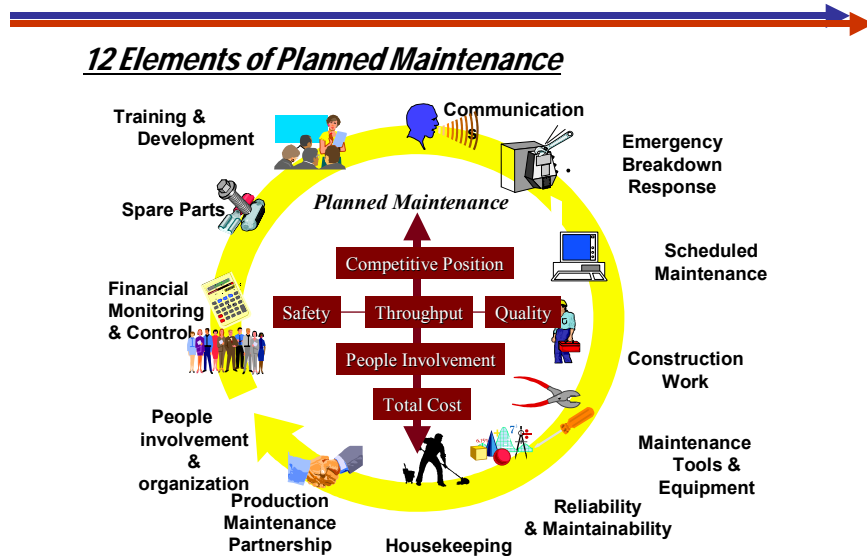
Figure 1: Planned Maintenance Process

There are twelve interdependent elements in planned maintenance that are integral to a successful process. Each element contributes to and provides support for the others. The linked elements, in total, provide the base for the Planned Maintenance Process (Figure 1):

- ✓ People Involvement and Organization
- ✓ Financial Monitoring and Control
- ✓ Spare Parts Availability
- ✓ Training
- ✓ Communications
- ✓ Emergency Breakdown Response
- ✓ Scheduled Maintenance
- ✓ Construction Work
- ✓ Maintenance Tools and Equipment Availability
- ✓ Reliability and Maintainability
- ✓ Housekeeping and Cleaning
- ✓ Production Maintenance Partnership

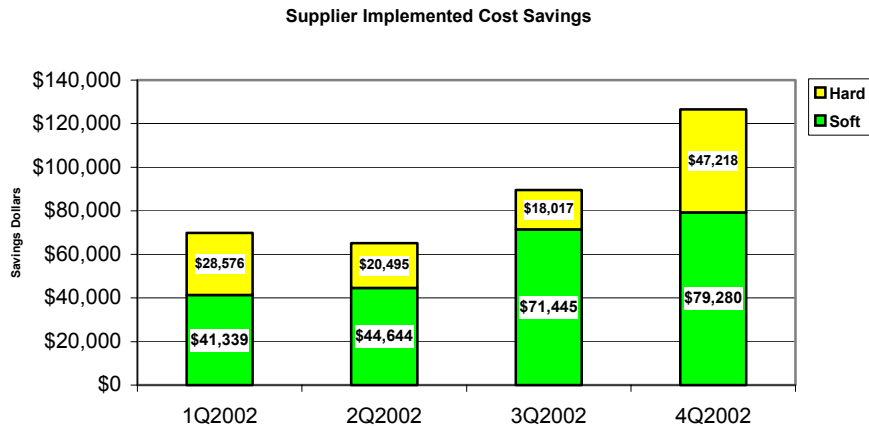
Figure 2: Supplier Program Cost Savings, 2002

Commodity Management is the term that Allison Transmission uses for the partnership program with our primary motor supplier. Some of the key features that are realized include improved quality of service and reduced operating and inventory costs. The stored Allison spare inventoried motors are kept at supplier’s warehouse. Subsequently, the supplier meets monthly with Allison personnel and reports on purchases, replacements, delivery time and hard and soft savings (Figure 2).

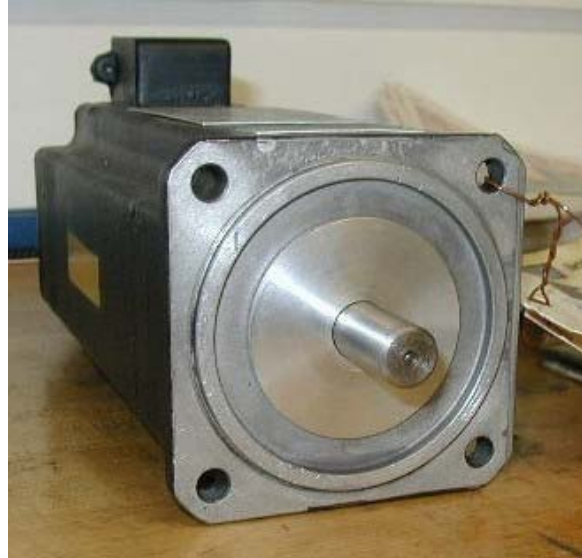
Figure 3: Servo Motor

In one department, a servomotor had failed seventeen times in ten months. The supplier was called in to assist in determining a root cause and a corrective action plan. The motor was in a wet harsh area that had a lot of coolant fluid. The vendor suggested a slinger on the motor shaft and a special seal process to keep the motors from prematurely failing. The company's motor supplier identified these modifications with a yellow stripe to indicate the motor was modified (Figure 3). To date the servomotor has not had another winding failure due to contamination.

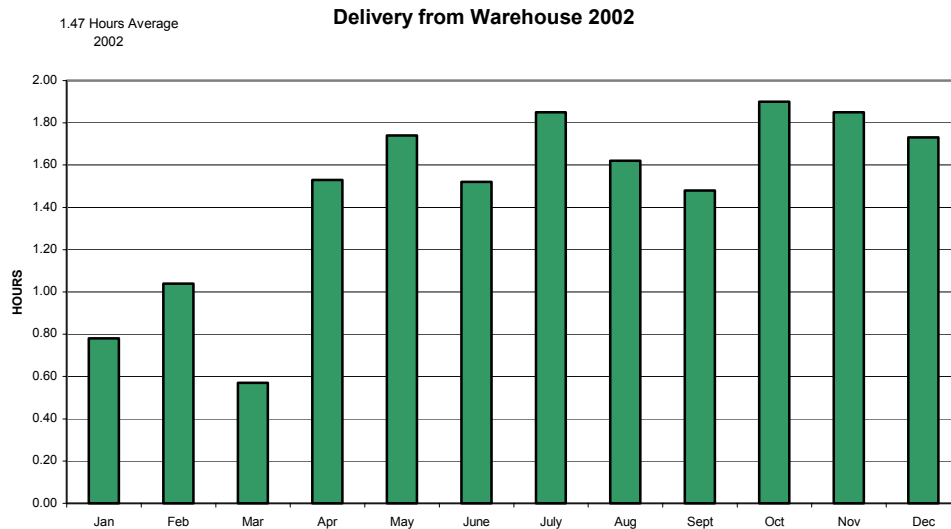
Figure 4: Warehouse Delivery Times

This partnership with the motor repair shop has proven to be very effective. Allison has the ability to call 24 hours a day, seven days a week in order to have a stored motor delivered and on its dock within two hours (Figure 4). The response time has been invaluable in planning production schedules. Allison also has access to the motor supplier subject matter experts. As a result, we consider the supplier part of our reliability toolbox. In the end, the motor shop supplier answers to Allison Transmission's Commodity Management Team, which is comprised of the QNPM rep, electricians from the motor shop and reliability department, the spare parts team, maintenance supervisors and individuals from the finance department.

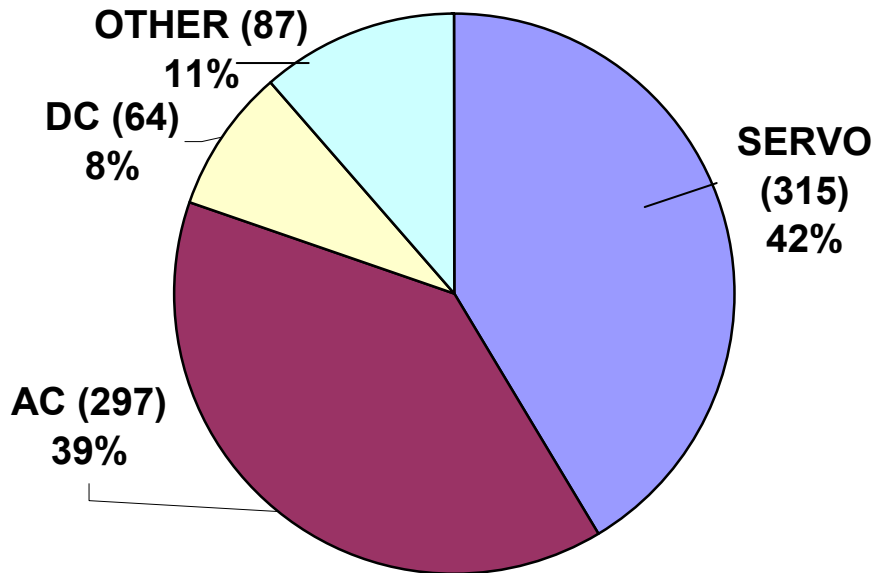
Figure 5: Motor Failures in 2002

Allison Transmission's motor program is a crucial component within operations. With MCA motors that have problems can be tested to confirm the fault, before being removed and sent out for repair. If a motor problem is not found, the electrician helps the service technician find a root cause. Motors that are difficult to install are tested prior to calling machine repair personnel for installation. Motors in the supplier's warehouse are audited on a quarterly basis with an MCA test. Some routes have been established due to repetitive motor failures, these motors are tested and trended monthly as part of the MCA process. Motors with pumps are tested prior to rebuilding the pump in order to determine if the motor pump combination may be more economical to replace than to rebuild. The breakdown of the different types of motors repaired or replaced during 2002 can be seen in Figure 4.

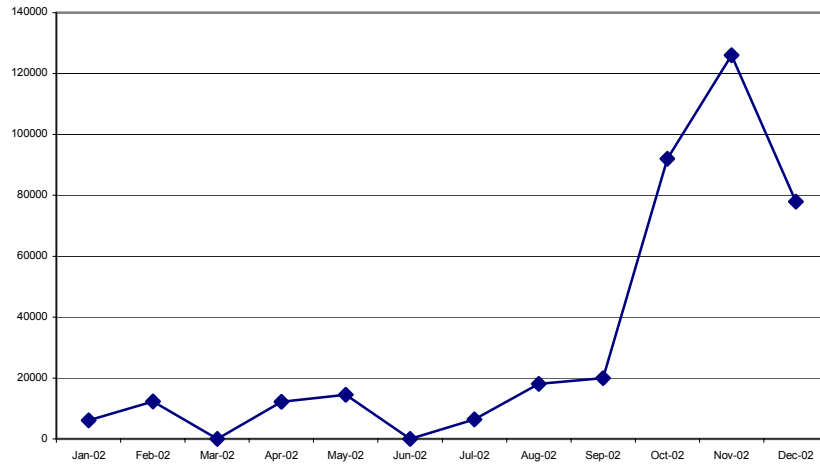
Figure 6: MCA Cost Avoidance for 2002

Allison Transmission prefers proactive vs. reactive maintenance particularly from a financial perspective. For instance, the total cost savings avoidance at Allison attributable to the MCA program in 2002 was \$307,664 (Figure 6).
